AMD-K6™

MMX™ Enhanced Processor

Revision Guide

Publication # 21266	Rev: E	Amendment/0
Issue Date: August 1997

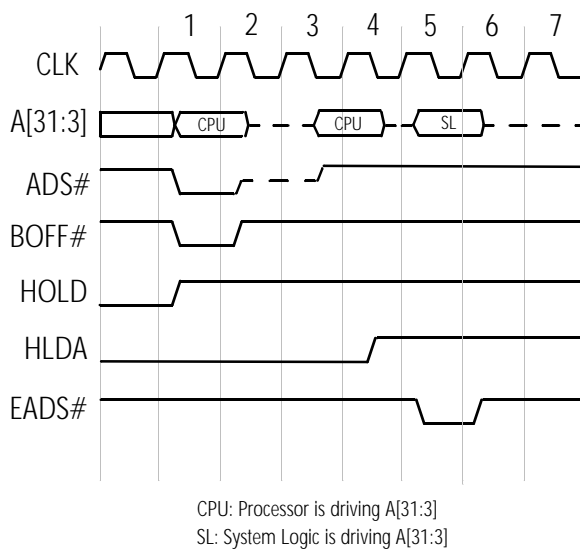
Figure 1. AMD-K6™ Processor Assertion of **HLDA** Due to Simultaneous **BOFF#**/**HOLD** Assertion

Non-conformance. If **BOFF#** and **HOLD** are sampled asserted on the same clock edge that negates **ADS#**, the processor asserts **HLDA** two clock edges after **HOLD** is sampled asserted.

- If the system logic asserts **BOFF#** for a duration of one clock, anticipates the assertion of **HLDA** in clock 3 (see Figure 1)—which is the normal specified operation—and drives the address bus and **EADS#** for an inquire cycle in clock 3, then the processor will not sample **EADS#** asserted. In addition, address bus contention will occur in clock 3.

- If the system logic asserts **BOFF#** for a duration of two clocks, anticipates the assertion of **HLDA** in clock 3, and drives the address bus and **EADS#** for an inquire cycle in clock 3, then the processor will not sample **EADS#** asserted. (No address bus contention occurs in this case.)

- If the system logic asserts **BOFF#** for a duration of one clock, anticipates the assertion of **HLDA** in clock 3, and drives the address bus and **EADS#** for an inquire cycle in clock 4, then address bus contention may occur in clock 4. (The processor will sample **EADS#** asserted in this case.)

If the processor does not sample **EADS#** asserted during an inquire cycle, cache/memory incoherency will occur. Address bus contention can affect the reliability of the processor and the system logic.

Suggested Workaround. The system logic must sample the assertion of **HLDA** before asserting **EADS#** and driving the address bus for an inquire cycle—as shown in clock 5 of Figure 1.
