AMD-K6[®]

Processor Revision Guide

Model 6

| Publication # 21266 Rev: G Amendment/0 Issue Date: August 1998 |

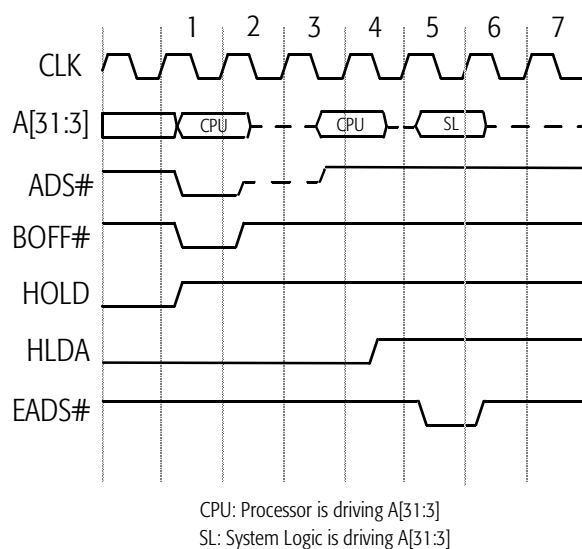
Figure 1. AMD-K6[®] Processor Assertion of HLDA Due to Simultaneous BOFF#/HOLD Assertion

Non-conformance. If BOFF# and HOLD are sampled asserted on the same clock edge that negates ADS#, the processor asserts HLDA two clock edges after HOLD is sampled asserted.

- If the system logic asserts BOFF# for a duration of one clock, anticipates the assertion of HLDA in clock 3 (see Figure 1)—which is the normal specified operation—and drives the address bus and EADS# for an inquire cycle in clock 3, then the processor will not sample EADS# asserted. In addition, address bus contention will occur in clock 3.

- If the system logic asserts BOFF# for a duration of two clocks, anticipates the assertion of HLDA in clock 3, and drives the address bus and EADS# for an inquire cycle in clock 3, then the processor will not sample EADS# asserted. (No address bus contention occurs in this case.)

- If the system logic asserts BOFF# for a duration of one clock, anticipates the assertion of HLDA in clock 3, and drives the address bus and EADS# for an inquire cycle in clock 4, then address bus contention may occur in clock 4. (The processor will sample EADS# asserted in this case.)

If the processor does not sample EADS# asserted during an inquire cycle, cache/memory incoherency will occur. Address bus contention can affect the reliability of the processor and the system logic.

Suggested Workaround. The system logic must sample the assertion of HLDA before asserting EADS# and driving the address bus for an inquire cycle—as shown in clock 5 of Figure 1.
