Pentium® Processor Specification Update

Release Date: November, 1996

Order Number 242480-023

The Pentium processor may contain design defects or errors known as errata. Characterized errata that may cause the Pentium processor's behavior to deviate from published specifications are documented in this specification update.

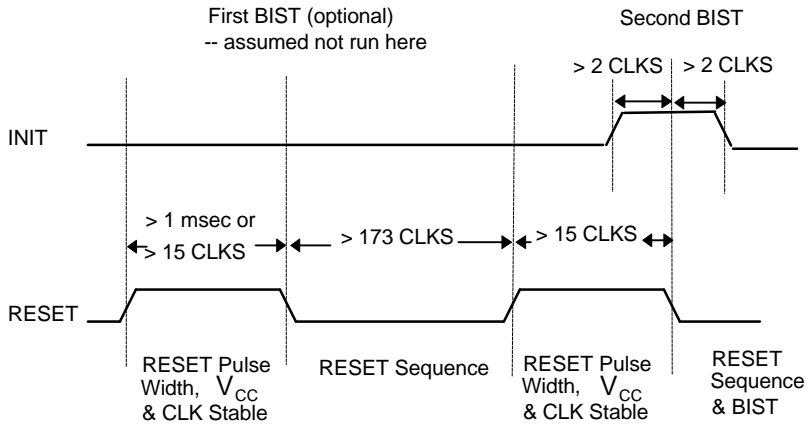
21. Power-Up BIST Failure

1. Invoke a double RESET — All false BIST failures have occurred during cold RESET. In order to accurately execute BIST, a double RESET sequence may be performed as shown in the figure below:

The first RESET pulse is used to ensure that all logic used in the BIST test is correctly initialized; optionally, INIT may be driven high to enter BIST at the falling edge of the first RESET. In this case the results of the first BIST should be ignored.

After deassertion of the first RESET pulse, a minimum of 173 clocks must elapse before assertion of the second RESET. (Note that if BIST was entered at the end of the first RESET, this 173-clock requirement is satisfied by the time required to complete the first BIST.) During the second RESET, INIT is toggled high in order to run the 'real' BIST. This BIST correctly returns results in EAX.

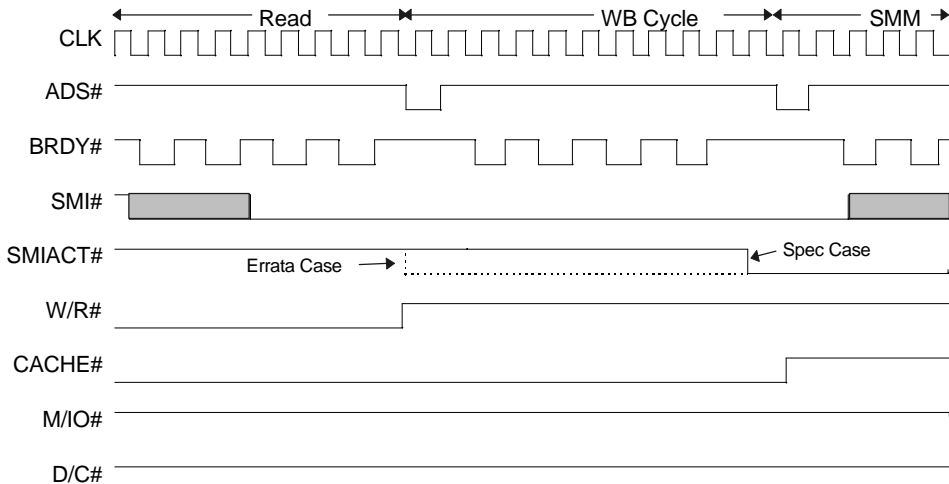
PROBLEM: If a data read cycle triggers a replacement writeback cycle and the SMI# signal is asserted before the last BRDY# of the read cycle, the processor may assert the SMIACK# signal prematurely. It occurs on all steppings when the processor is in 2/3 bus mode. **If the processor is in 1/2 bus mode it will not exhibit this erratum for C2 and subsequent steppings.**

Before the processor asserts SMIACK# in response to an SMI# request, it should complete all pending write cycles (including emptying the write buffers). However, if the appropriate conditions occur, the SMIACK# signal may get asserted during the replacement writeback cycle, at anytime during the writeback cycle. See below diagram.

IMPLICATION: If the SMIACT# signal is used by the system logic to decode SMRAM (e.g., SMRAM is located in an area that is overlaid on top of normal memory space, e.g. system, video etc.), then the replacement writeback cycle with SMIACT# asserted could occur to SMM space. Systems that locate SMRAM in its own distinct memory space (non-overlaid) should not experience data corruption once the SMRAM has been initialized and relocated.

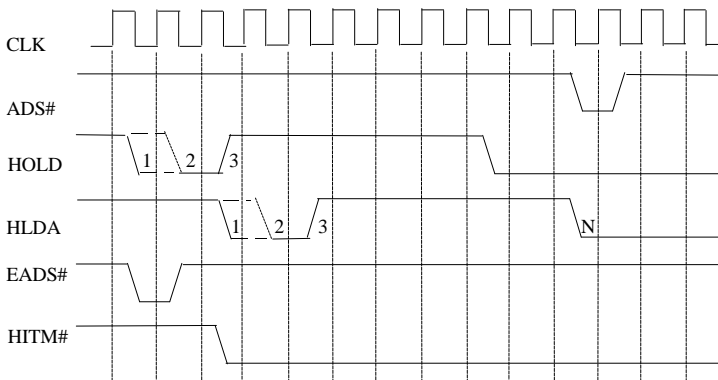
Snoop Writeback Cycle Delayed

IMPLICATION: If the system expects a cycle, for example a writeback cycle, and depends on this cycle to commence within the HLDA deassertion window, then the system may not complete the handshake and cause a hang.

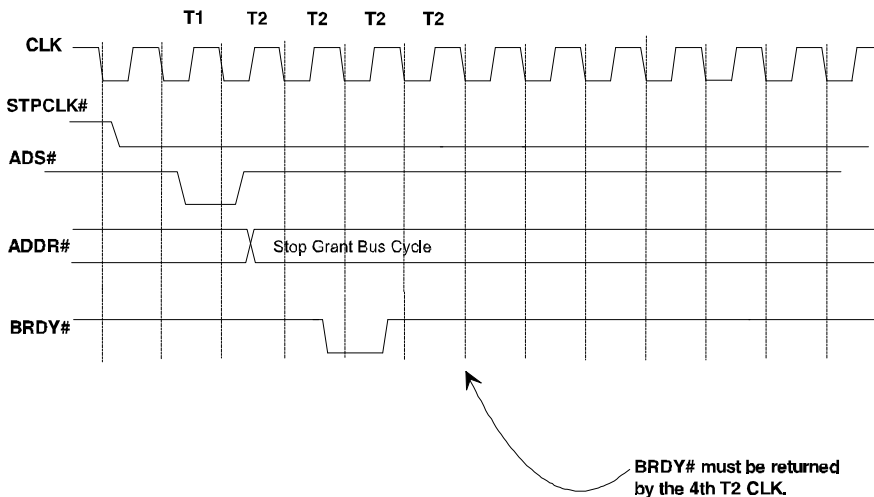
IMPLICATION: This problem occurs only in dual processor systems and will cause one of the processors to hang.

1. Do not assert STPCLK#.
2. Ensure that BRDY# is asserted within 4 CLKs after the Stop Grant bus cycle has begun.

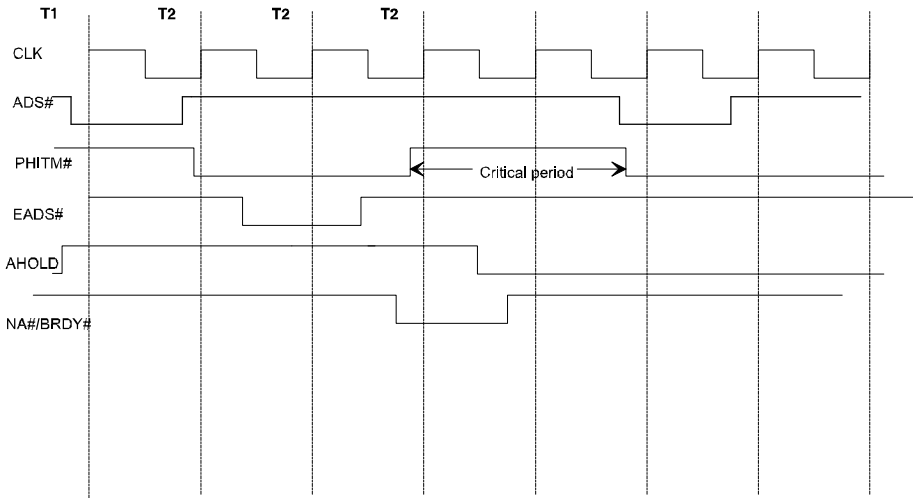
6. After the memory-write cycle is complete, the LRM performs its writeback.
7. The MRM then re-issues the memory write-cycle again. This cycle, now being issued for the third time, causes an internal hangup in the MRM.

IMPLICATION: If a memory write or memory read cycle is pending on the bus and an external snoop occurs, one of the processors may hang.

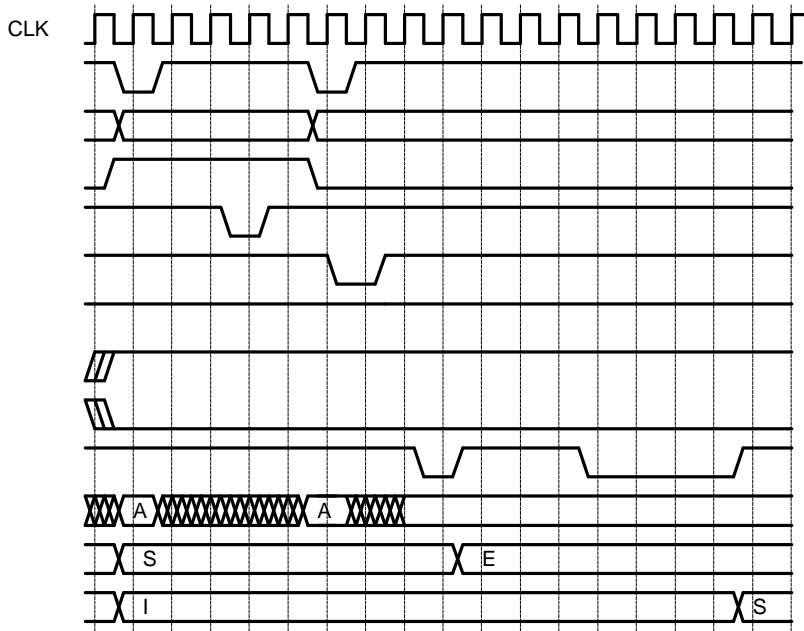
line state is (S) which will generate the PHIT#, and no PHITM#, the transition to the (E) state has been posted but is not performed until the BRDY# of the WRITE cycle.

IMPLICATION: If the described conditions are met, then an additional write to the same address in processor 1 will cause a cache state transition from (E) to (M) and will not generate a bus cycle. This will mean that the data in processor 2 is stale but it could continue operating with the stale data. For example: When 2 processors are sharing a cached semaphore, and processor 1 is updating the semaphore just as processor 2 is reading the semaphore, then processor 2 would eventually end up with stale data in its cache. Due to the nature of the problem, this could cause a number of unknown system problems and may or may not cause a system to hang.

WORKAROUND: Disable pipelining while using dual processing, this is done by not asserting NA#.

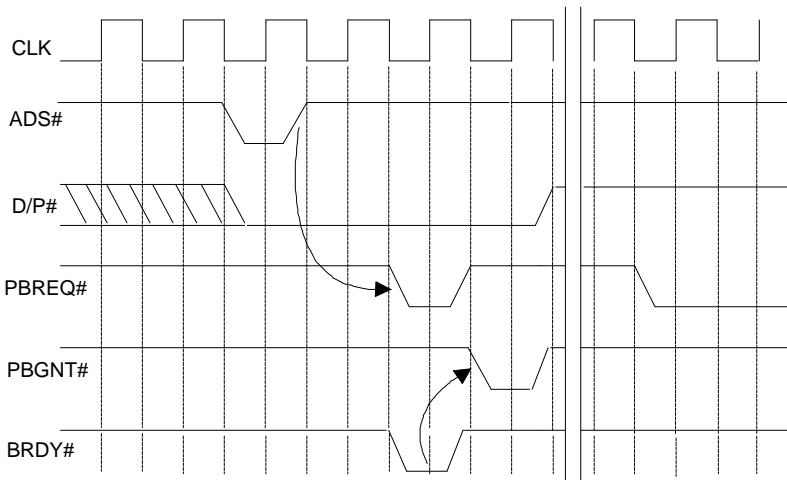
7. CPU A asserts PBREQ# to CPU B in order to obtain bus ownership back to run its pending cycle.
8. CPU B, however does not grant the bus back to CPU A since it needs to run a bus cycle before relinquishing the bus ownership. Since interrupts are disabled and the processor is executing in a tight 'spin' loop, it does not have any bus cycles to run and does not relinquish the bus.

IMPLICATION: A system lockup can occur because one CPU requests the bus, while the other CPU does not relinquish bus control. Running Windows NT operating system, it has been observed that when the hang condition occurs, the code inside the Windows NT kernel is always inside a very tight code loop, with at least

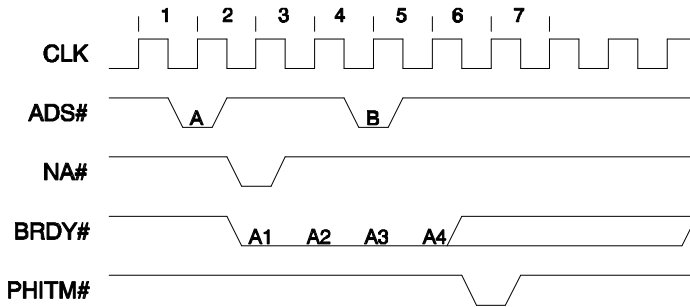
- The processor issues read cycle A which may be pipelined into an earlier (not shown) cycle.
- Cycle A will be completed by the system as a 2-1-1-1 (zero wait state) cycle.
- One clock after issuance of the ADS#, NA# is asserted by the system.
- A pipelined cycle (B) is asserted by the MRM in clock 4.
- Cycle A completes on the bus in clock 5.
- One clock later, PHITM# is issued by the LRM.

Specifically given the above conditions, the error condition occurs internally in the CPU due to the assertion of PHITM# or BOFF# one clock after the final BRDY# of cycle A. If this occurs, the CPU will respond to the PHITM# or BOFF# by subsequently re-issuing both cycles A and B, where expected operation would be that only cycle B is re-issued.

IMPLICATION: The code fetch or data read cycle (A) will be re-issued even though it is already completed. The second occurrence of the cycle, even if harmless from a system point of view, will confuse the internal state of the CPU and may cause subsequent CPU mis-operation.

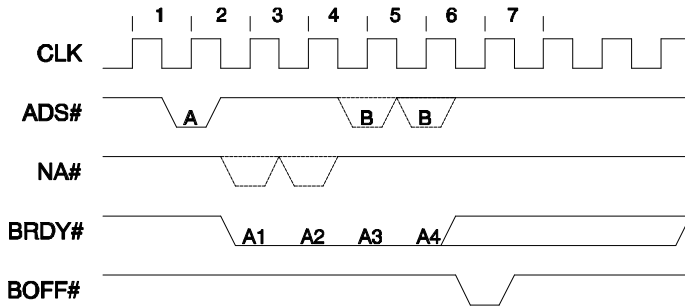
CASE 2:

- The processor issues read cycle A which may be pipelined into an earlier (not shown) cycle.
- Cycle A will be completed by the system as a 2-1-1-1 (zero wait state) cycle.
- One or two clocks after issuance of the ADS#, NA# is asserted by the system.
- A pipelined cycle (B) is asserted by the MRM in either clock 4 or clock 5.
- Cycle A completes on the bus in clock 5.
- One clock later, BOFF# is issued by the system.

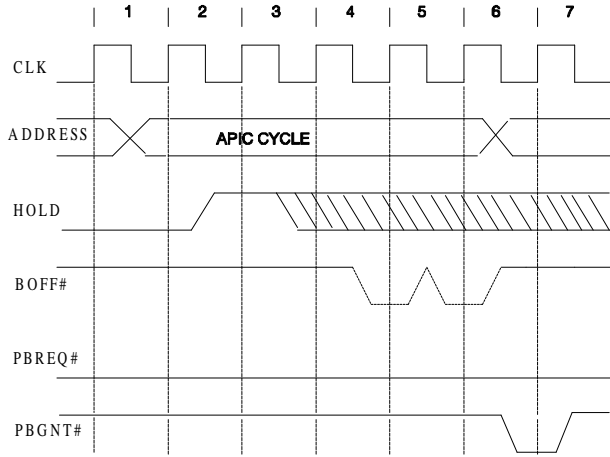
1. One of the CPUs initiates an internal APIC cycle (read or write). The LRM CPU requests ownership of the bus by asserting PBREQ#
2. HOLD is asserted during the APIC cycle
3. BOFF# is asserted before the APIC cycle gets completed, two or three clocks after HOLD is asserted (as shown in figure below)
4. Once BOFF# is deasserted, both processors may assume ownership of the bus at the same time resulting in possible contention of the CPU pins.

IMPLICATION: This problem affects dual processing (with CPU local APIC enabled) that assert HOLD and BOFF#. When the problem occurs, the dual processing arbitration machines of both processors get out of synchronization causing both processors to park on the bus. This will result in a system hang.

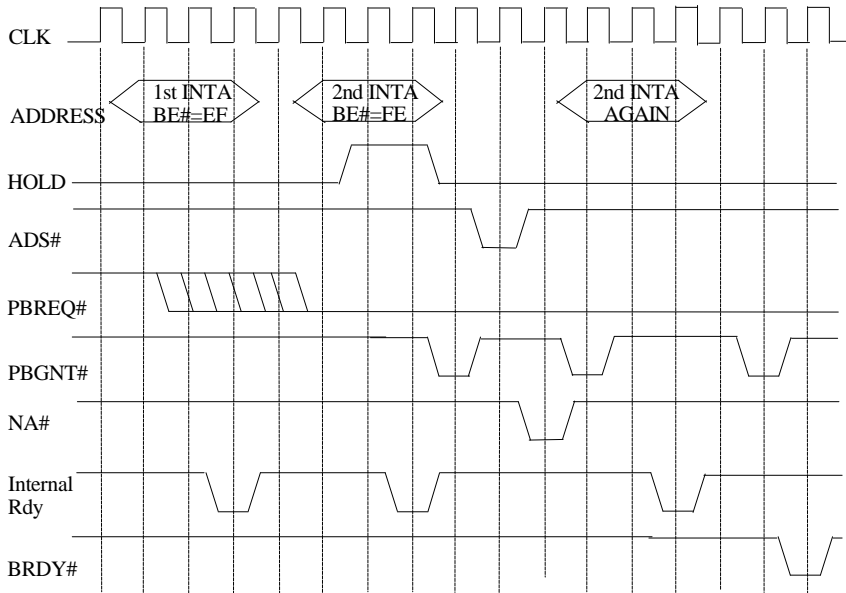
13DP. System Hang After Hold During Local APIC 2nd INTA Cycle

1. One of the CPU's (i.e. CPU A) initiates the first and second internal APIC INTA cycles. The INTA cycles are not driven on the external bus. CPU B requests ownership of the bus by asserting PBREQ#.
2. HOLD is asserted during the 2nd INTA cycle and PBGNT# is asserted.
3. CPU B issues a read or write cycle and receives NA# before completion of the cycle. The bus is granted back to CPU A.
4. CPU A reissues the second INTA cycle and grants the bus to CPU B.
5. CPU A hangs because the internal Rdy# and BRDY# were recognized out of order.

IMPLICATION: Asserting HOLD during the second INTA cycle causes the processors to lose synchronization. The external cycle completes on the bus after the INTA cycle completes which hangs the system.

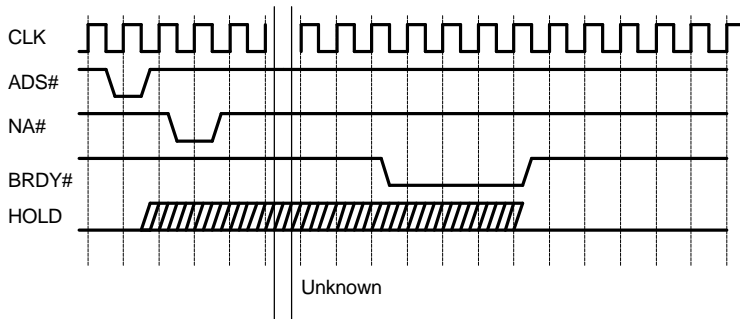
PROBLEM: This is an APIC related dual processor erratum: When an APIC read cycle is interprocessor pipelined into any other allowable cycle, and HOLD is prior to the last BRDY# of the outstanding cycle, the MRM processor will hang.

IMPLICATION: A system that uses dual processor with pipelining enabled, is subject to periodic lockups if HOLD/HLDA# protocol is used.

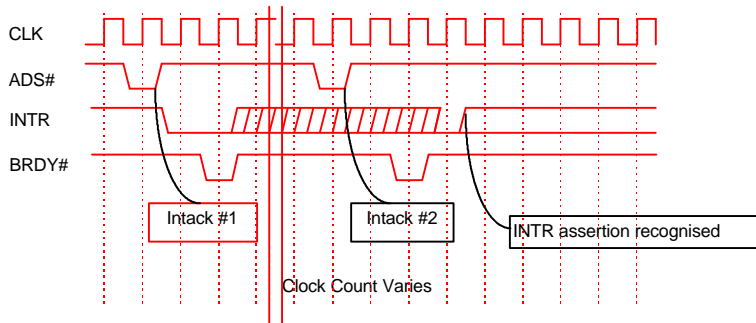
PROBLEM: This erratum affects APIC in through Local (virtual wire) mode. If a uniprocessing or dual processing system is using a Pentium processor with the APIC in through Local (virtual wire) mode, and the chip set is able to re-assert the INTR line prior to completion of the second Interrupt acknowledge cycle (from a prior assertion of the INTR line), then the processor will neither recognize nor service the second interrupt. The assertion edge of INTR has to occur after the completion of the second IntAck BRDY#, if there is a transition and this transition is held high during the restricted time period, this INTR will not be recognized. Software disabling of the APIC by clearing bit 8 of the SVR (spurious vector interrupt register) will not prevent this from occurring.

IMPLICATION: If the conditions listed above are met the system may hang up since there would be an interrupt that would not get serviced.

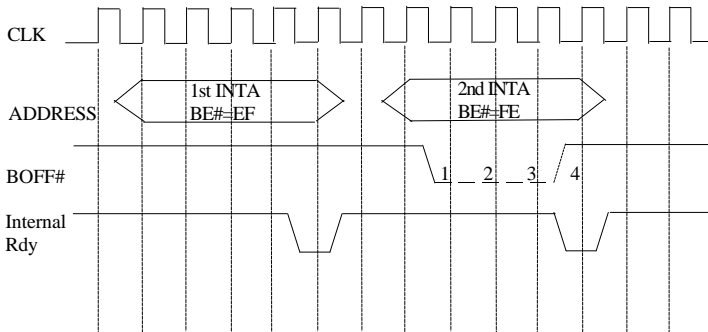
BOFF# During 2nd INTA (Non-remote Read)

IMPLICATION: If the system does not assert BOFF# when the processor bus is idle, then this problem will not occur. Internal APIC INTA cycles are run only when the bus is idle, thus asserting BOFF# during an external bus cycle (e.g. started by an ADS#) will avoid these circumstances. In systems that can assert BOFF# when the bus is idle, asserting BOFF# for a least 4 clocks will avoid the problem for non-remote read cases. Note that there may be other implementations that guarantee BOFF# is not asserted in the problematic window. For example, if BOFF# is only asserted with AHOLD active and AHOLD always precedes BOFF# by at least 4 clocks, the erratum is avoided.

If a remote read is occurring (e.g. between two processors) this will delay completion of the second INTA cycle by up to 8 clocks (i.e. bus clocks), and BOFF# asserted during this time may hang the system. Remote reads are typically performed during system debug and not in normal operation. Not performing remote reads will avert this case.

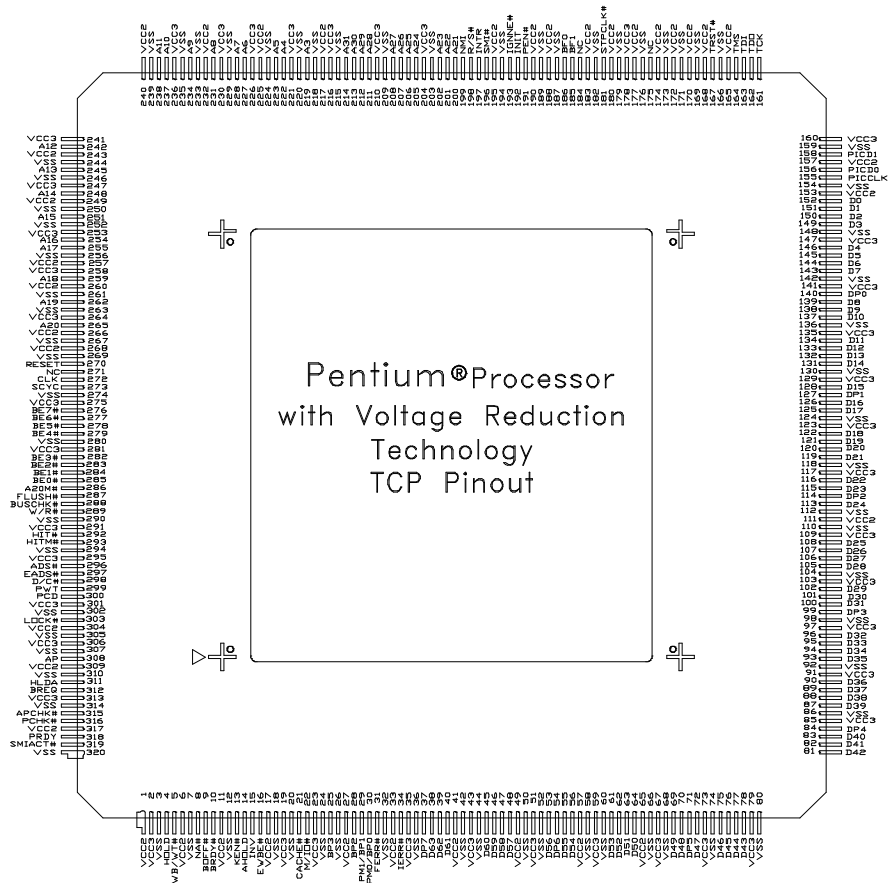
The TCP pinout drawing on page 8 of the Pentium Processor with Voltage Reduction Technology Data Sheet was inadvertently rotated. The correct orientation is shown below.
