Pentium® Processor Specification Update

Release Date: November, 1996

Order Number 242480-023

The Pentium processor may contain design defects or errors known as errata. Characterized errata that may cause the Pentium processor's behavior to deviate from published specifications are documented in this specification update.

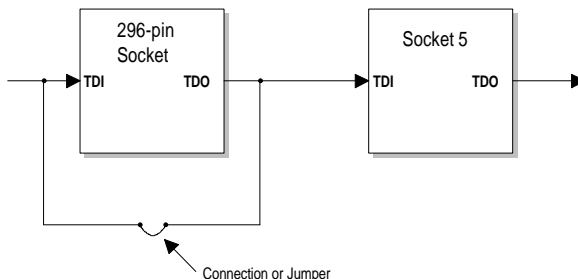
Other implications of this workaround include Boundary Scan, and any other signals not connected together between Socket 5 and the 296-pin SPGA socket site.

If Socket 5 follows the 296-pin socket in the Boundary Scan chain, the TDI input and TDO output of the 296-pin socket site must be connected together by the OEM prior to system sale in order to skip this socket site and complete the path to socket, as shown in the following figure. This connection is necessary only if Boundary Scan will be used by end-users after system sale.

All of the signals which are not connected together in a dual socket system must be handled by both socket sites if the feature is desired. These signals are APCHK#, BP[3:0], IERR#, PM[1:0], PRDY, and R/S#.

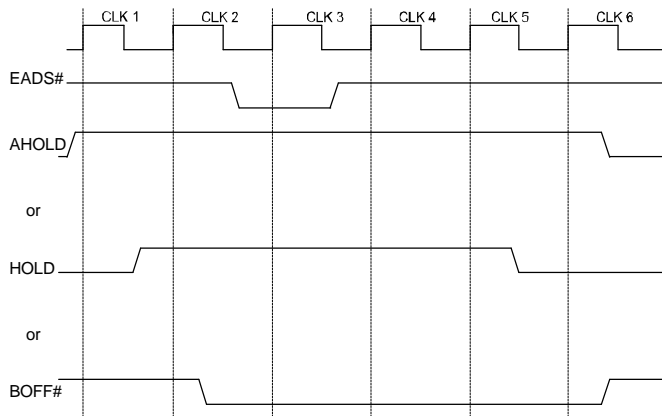
All of the listed workarounds prevent the MRM processor from starting a new cycle, thus preventing the third restart of the pending cycle.

1. Ensure that NA#/BRDY# is asserted before, or after the "critical period". (the critical period is the two CLK period after EADS# is sampled active.)
or
2. Ensure that AHOLD is held high for a minimum of three clocks after EADS# has been sampled active. See the following figure.
or
3. Drive HOLD for two clocks after the EADS# was sampled active. Removal of HOLD can be done without regard to the HLDA signal. See the following figure.
or
4. Drive BOFF# for 3 clocks after the EADS# was sampled active. See the following figure.

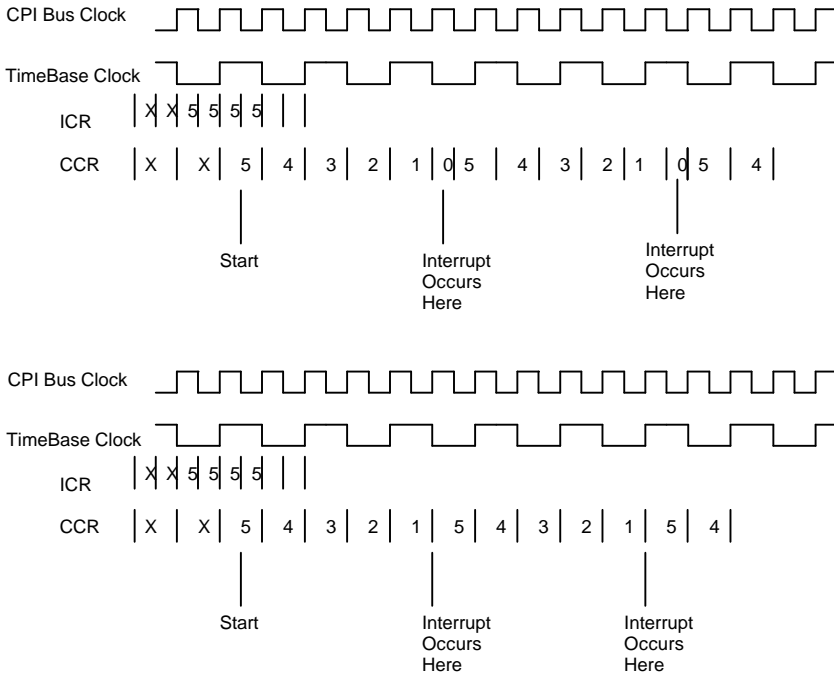
The APIC Timer functions correctly, but there is one timer "tick" that is a different pulse width than the other timer "ticks". The countdown performs correctly regardless of the divisor that is programmed, each of these ticks is of the same pulse width, but the last tick is held for just one single timer clock regardless of the divisor programmed. This results in a slightly inaccurate timer. This last tick pulse width is shown in the top diagram. The lower diagram shows how the accuracy of the timer will be corrected in a future stepping. This phenomenon occurs when the timer is used as a single shot generator as well.

NOTE: The CPU Bus clock in which the CCR is loaded from the ICR occurs one clock after the ICR is loaded.
