Pentium® Processor Specification Update

Release Date: September, 1997

Order Number 242480-030

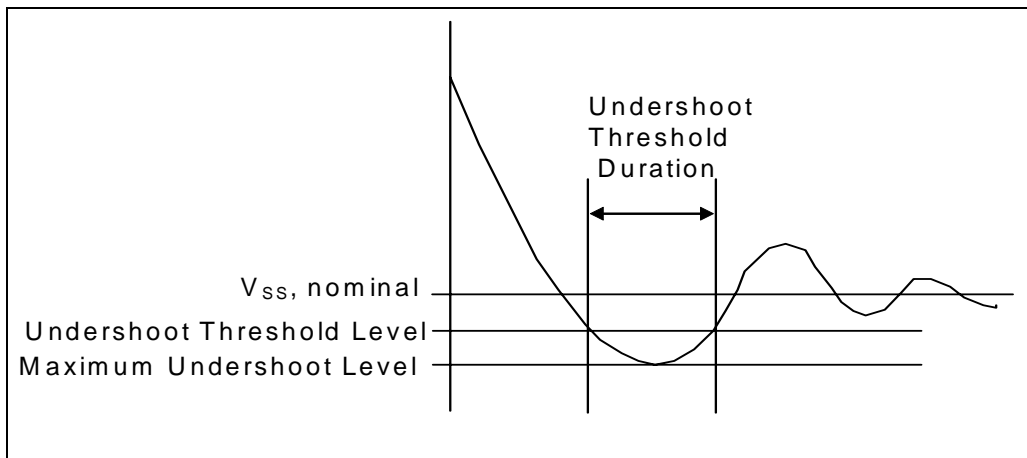
Figure14-1. Maximum Undershoot Level, Undershoot Threshold Level, and Undershoot Threshold Duration

MAXIMUM RINGBACK SPECIFICATION: The maximum ringback of CLK associated with its low state (undershoot) must not exceed 0.8V as shown in Figure 14-1.

UNDERSHOOT THRESHOLD DURATION SPECIFICATION: A snapshot of the clock signal should be taken at 500 mV/div and 500 pS/div (for CLK). Adjust the vertical position and horizontal offset position to view the threshold duration. The undershoot threshold duration is defined as the sum of all time during which the clock signal is below -0.5V within a single clock period. The undershoot threshold duration must not exceed 20% of the period.

This undershoot specifications are illustrated graphically in Figure 14-1 and Figure 14-2.
